**Flood Control Project Maintenance
Levee Inspections**

Maintenance Issue Types Only, Levee Inspection Report By Mile - Fall 2018

Reclamation District No. 0404 Boggs

Waterway	Bank	Unit Miles	Inspection Start/End	Inspector
Unit No. 01 San Joaquin River	Right	2.35	09/25/2018 09/25/2018	Richard Willoughby

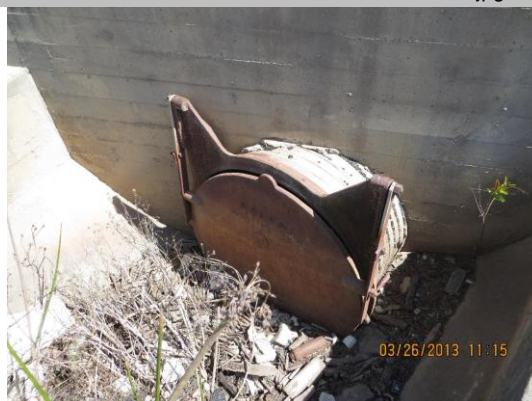
Photo 2 of 3 : UCIP_FA_2018_52607_19962.jpg

WS- drainage outlet structure and CM pipe with flapgate

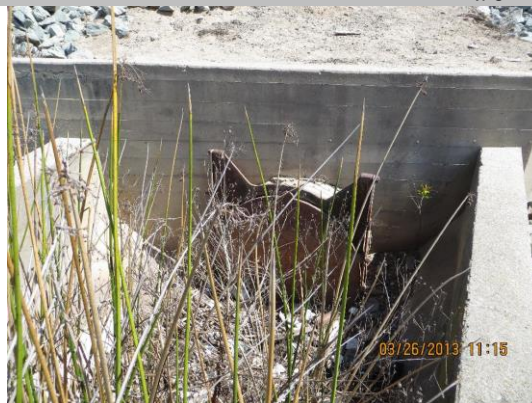
Photo 3 of 3 : UCIP_FA_2018_52607_19961.jpg

WS- Debris and vegetation blocking CM drainage pipe

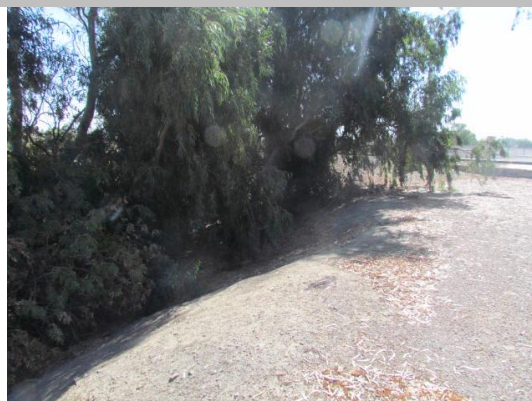
Photo 1 of 1 : FA_2018_RD0404_305_8_20180906_00004.jpg

LM Start	0.78	Rating **	M	Issue No.	8
LM End	0.78	Issue Type +	Ma	Location *	LS
Category	Earthen Levee			GPS Latitude/Longitude	
				Start	End
Item	Trim / Thin Trees			37.937395°	37.937395°
				-121.333883°	-121.333883°
DWR ID	DWR_RD0404_01_s_2013_8				
Comment Code					
T1 : Trim trees to at least five feet above ground level.					
Inspector Comment					
Trees are blocking view of the slope.

Looking southeast at dense trees on landward slope and toe.

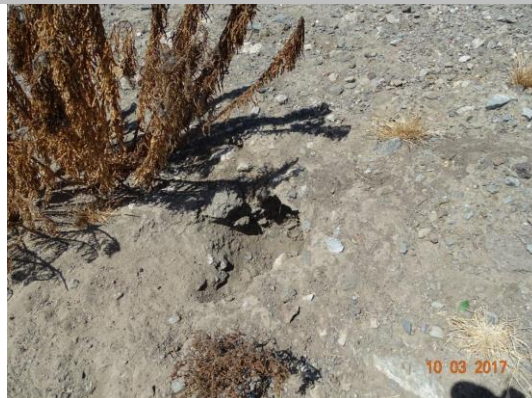
Photo 1 of 2 : FA_2018_RD0404_305_42_20180906_00016.jpg

LM Start	0.98	Rating **	U	Issue No.	42
LM End	0.98	Issue Type +	Ma	Location *	WS
Category	Earthen Levee			GPS Latitude/Longitude	
				Start	End
Item	Animal Control			37.935918 °	37.935918 °
				-121.331032 °	-121.331032 °
DWR ID	DWR_RD0404_01_s_2017_42				
Comment Code					
A3 : No rodents visible, but rodent burrows visible; need to backfill and compact or grout burrows.					
Inspector Comment

View of the waterside slope looking southwest.

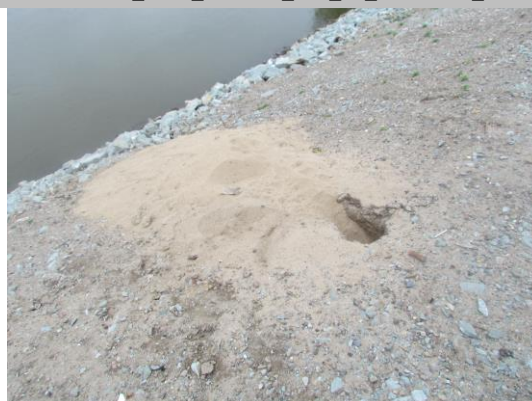
Photo 2 of 2 : FA_2018_RD0404_305_42_20180906_00017.jpg

Looking northwest at large animal hole (den) on waterward shoulder.

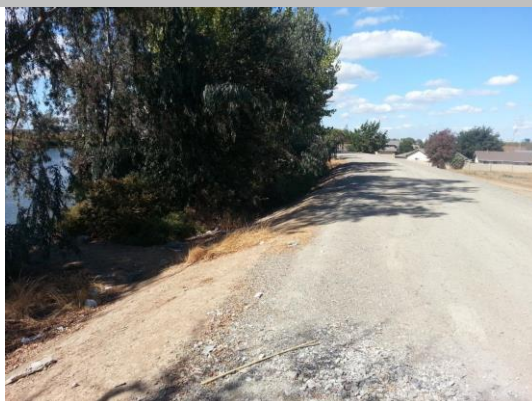
Photo 1 of 1 : FA_2018_RD0404_305_100_20180906_00018.jpg

LM Start	1.35	Rating **	M	Issue No.	100
LM End	1.35	Issue Type +	Ma	Location *	WS
Category	Earthen Levee			GPS Latitude/Longitude	
				Start	End
Item	Trim / Thin Trees			37.931945°	37.931945°
				-121.327150°	-121.327150°
DWR ID	DWR_RD0404_01_s_2012_100				
Comment Code					
T1 : Trim trees to at least five feet above ground level.					
Inspector Comment

Looking northwest at untrimmed trees on waterward slope.

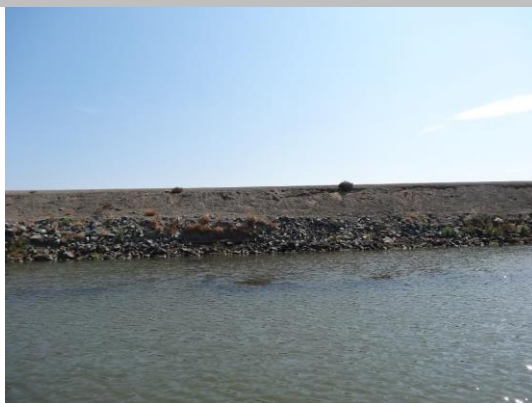
Photo 1 of 2 : FA_2018_RD0404_305_11_20180906_00005.jpg

LM Start	1.44	Rating **	M	Issue No.	11
LM End	1.46	Issue Type +	Ma	Location *	WS
Category	Supplemental			GPS Latitude/Longitude	
				Start	End
Item	DWR Erosion Survey			37.930450 °	37.930450 °
				-121.327450 °	-121.327450 °
DWR ID	RD0404U01RM42.02				
Comment Code					
Inspector Comment					
09/13/2017: No significant change observed.					
07/25/2016: No significant change observed.					
06/24/2015: No significant change observed.					
06/19/2014: A series of scarp erosions have been found on the lower levee slope and at the levee toe. [2017 Site ID:RD0404U01RM42.02]

Front view of the erosion.

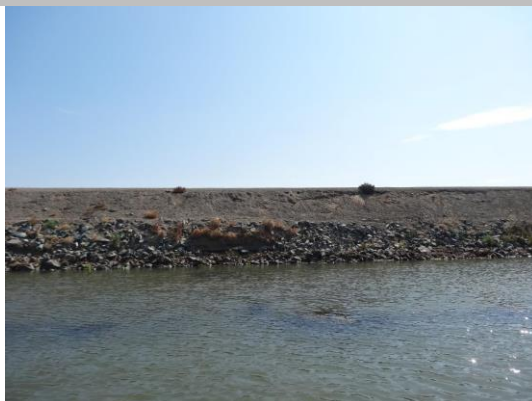
Photo 2 of 2 : FA_2018_RD0404_305_11_20180906_00006.jpg

Close view of the erosion. Note the protection on the lower levee slope.

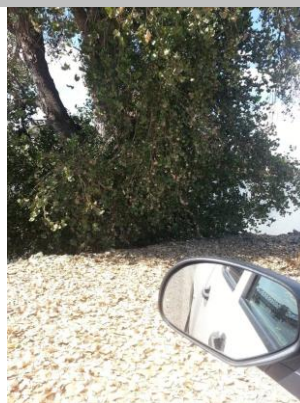
Photo 1 of 1 : FA_2018_RD0404_305_27_20180906_00011.jpg

LM Start	1.50	Rating **	M	Issue No.	27
LM End	1.50	Issue Type +	Ma	Location *	WS
Category	Earthen Levee			GPS Latitude/Longitude	
				Start	End
Item	Trim / Thin Trees			37.896544 °	37.896544 °
				-121.327121 °	-121.327121 °
DWR ID	DWR_RD0404_01_f_2016_27				
Comment Code					
T2 : Thin trees to allow visibility of the ground and room to flood fight.					
Inspector Comment

Looking west at untrimmed trees on waterward slope.

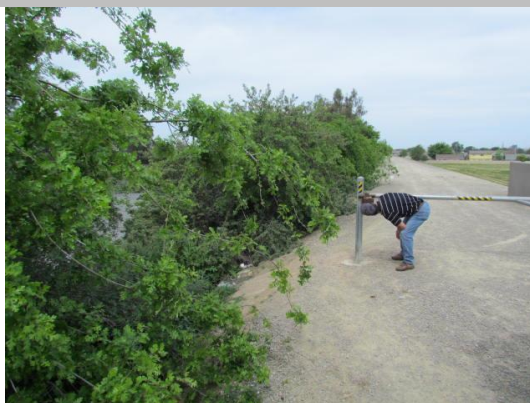
Photo 1 of 2 : FA_2018_RD0404_305_29_20180906_00012.jpg

LM Start	1.70	Rating **	A/W	Issue No.	29
LM End	1.77	Issue Type +	Ma	Location *	WS
Category	Earthen Levee			GPS Latitude/Longitude	
				Start	End
Item	Trim / Thin Trees			37.927517 °	37.926632 °
				-121.325515 °	-121.324868 °
DWR ID	DWR_RD0404_01_s_2015_29				
Comment Code					
T1 : Trim trees to at least five feet above ground level.					
Inspector Comment					
Dense untrimmed trees on waterward slope. Army Corp veg site.Tree and woody vegetation planted by the DWR but not being maintain according to agreement.

Looking north at dense vegetation on waterward slope.

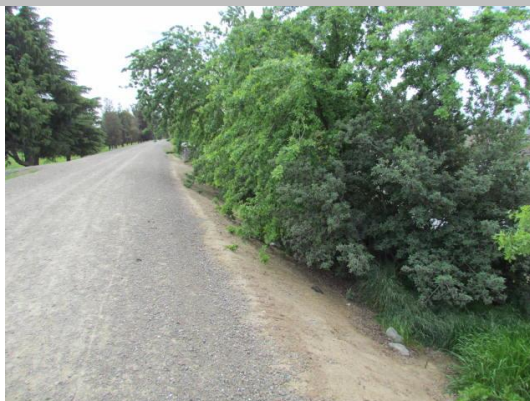
Photo 2 of 2 : FA_2018_RD0404_305_29_20180906_00013.jpg

Looking south at dense vegetation on waterward slope.

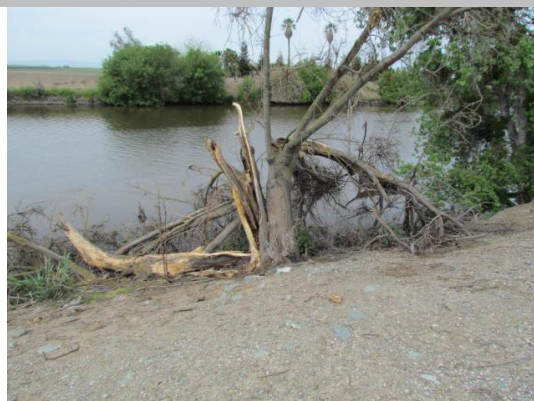
Photo 1 of 1 : FA_2018_RD0404_305_33_20180906_00014.jpg

LM Start	2.00	Rating **	U	Issue No.	33
LM End	2.00	Issue Type +	Ma	Location *	WS
Category	Earthen Levee			GPS Latitude/Longitude	
				Start	End
Item	Encroachments			37.923673 °	37.923673 °
				-121.323015 °	-121.323015 °
DWR ID	DWR_RD0404_01_s_2016_33				
Comment Code					
TR : Tree or limb					
Inspector Comment					
Dead tree on waterward slope

Looking west at dead tree on waterward slope.

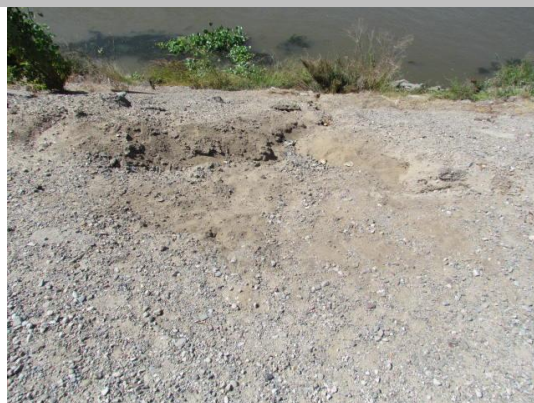
Photo 1 of 2 : FA_2018_RD0404_305_16_20180906_00008.jpg

LM Start	2.01	Rating **	M	Issue No.	16
LM End	2.01	Issue Type +	Ma	Location *	WS
Category	Earthen Levee			GPS Latitude/Longitude	
				Start	End
Item	Slope Stability			37.923470 °	37.923470 °
				-121.322978 °	-121.322978 °
DWR ID	DWR_RD0404_01_f_2013_16				
Comment Code					
S2 : Repair the levee slope damaged by foot traffic and prevent access where possible.					
Inspector Comment					
Slope damage due to foot traffic.

Looking west at slope damage due to foot traffic.

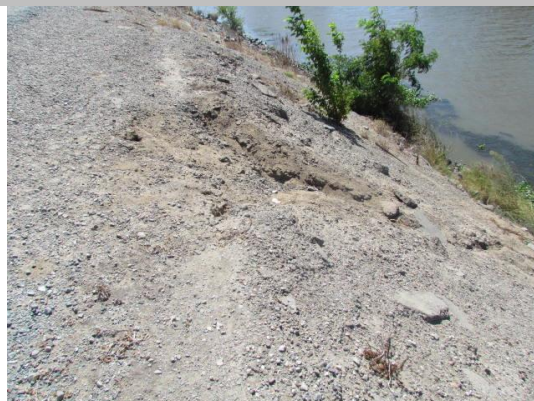
Photo 2 of 2 : FA_2018_RD0404_305_16_20180906_00009.jpg

Looking southwest at slope damage due to foot traffic.

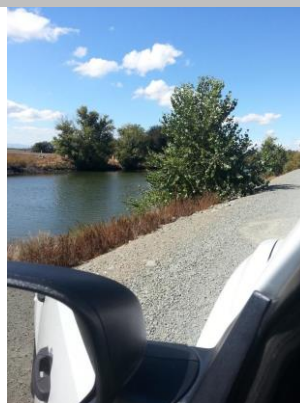
Photo 1 of 1 : FA_2018_RD0404_305_13_20180906_00007.jpg

LM Start	2.08	Rating **	M	Issue No.	13
LM End	2.08	Issue Type +	Ma	Location *	WS
Category	Earthen Levee			GPS Latitude/Longitude	
				Start	End
Item	Trim / Thin Trees			37.922669 °	37.922669 °
				-121.322272 °	-121.322272 °
DWR ID	DWR_RD0404_01_f_2012_13				
Comment Code					
T1 : Trim trees to at least five feet above ground level.					
Inspector Comment

Looking northwest at untrimmed tree on waterward slope.

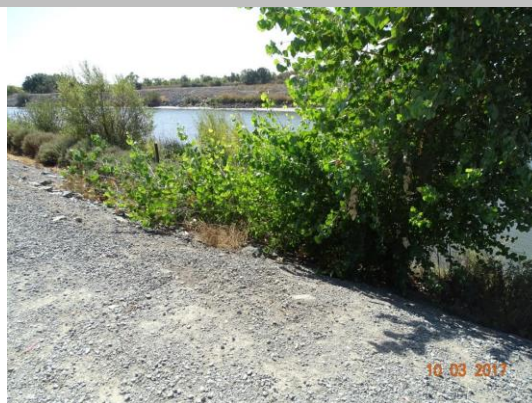
Photo 1 of 1 : FA_2018_RD0404_305_22_20180906_00010.jpg

LM Start	2.14	Rating **	M	Issue No.	22
LM End	2.14	Issue Type +	Ma	Location *	WS
Category	Earthen Levee			GPS Latitude/Longitude	
				Start	End
Item	Trim / Thin Trees			37.922040 °	37.922040 °
				-121.321446 °	-121.321446 °
DWR ID	DWR_RD0404_01_f_2017_22				
Comment Code					
T1 : Trim trees to at least five feet above ground level.					
Inspector Comment

View of the waterside slope looking south.

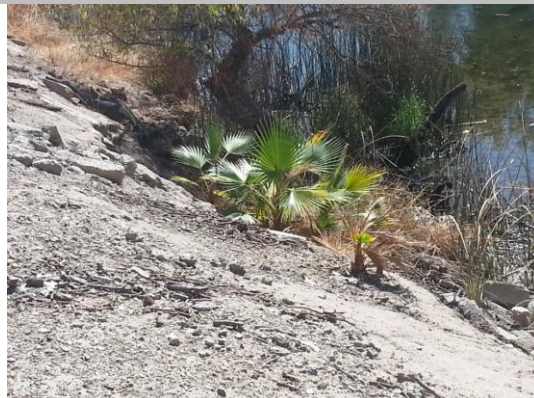
Photo 2 of 2 : FA_2018_RD0404_306_14_20180906_00004.jpg

LM Start	0.14	Rating **	U	Issue No.	14 (cont)	
LM End	0.14	Issue Type +	Ma	Location *	WS	
Category	Earthen Levee			GPS Latitude/Longitude		
				Start		End
Item	Erosion / Bank Caving			37.918875 °	37.918875 °	
				-121.316587 °	-121.316587 °	
DWR ID	DWR_RD0404_02_f_2017_14					
Comment Code						
E2 : Schedule repair of erosion site prior to the next inspection.						
Inspector Comment						
Erosion occurred winter 2017.

Looking southeast at erosion on waterward slope.

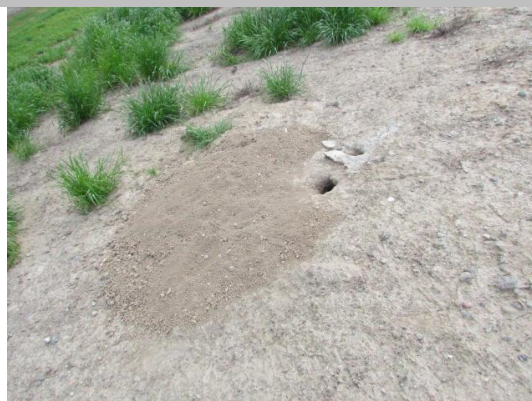
Photo 1 of 2 : FA_2018_RD0404_306_21_20180906_00009.jpg

LM Start	0.68	Rating **	U	Issue No.	21
LM End	0.94	Issue Type +	Ma	Location *	LS
Category	Earthen Levee			GPS Latitude/Longitude	
				Start	End
Item	Animal Control			37.919245 °	37.916652 °
				-121.307705 °	-121.305085 °
DWR ID	DWR_RD0404_02_s_2016_21				
Comment Code					
A1 : Exterminate rodents and backfill and compact or grout burrows.					
Inspector Comment					
Large holes noted on landward slope.

Looking northeast at large rodent hole on landward slope.

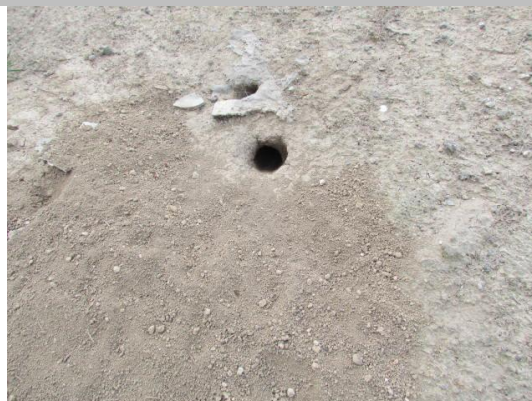
Photo 2 of 2 : FA_2018_RD0404_306_21_20180906_00010.jpg

Looking east at large rodent hole on landward slope.

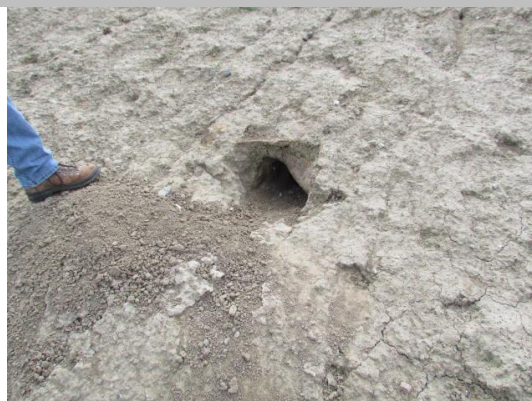
Photo 4 of 4 : FA_2018_RD0404_306_20_20180906_00008.jpg

LM Start	1.03	Rating **	U	Issue No.	20 (cont)	
LM End	1.08	Issue Type +	Ma	Location *	LS	
Category	Earthen Levee			GPS Latitude/Longitude		
				Start		End
Item	Animal Control			37.916302°	37.916383°	
				-121.303690°	-121.302802°	
DWR ID	DWR_RD0404_02_s_2016_20					
Comment Code						
A3 : No rodents visible, but rodent burrows visible; need to backfill and compact or grout burrows.						
Inspector Comment						
Large rodent holes on landward slope and levee crown.

Looking at rodent hole on landward slope.

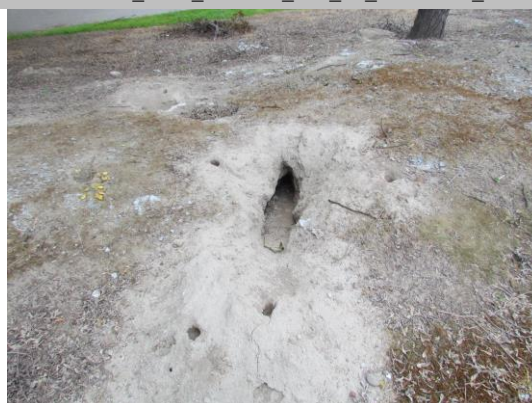
Photo 1 of 2 : FA_2018_RD0404_306_11_20180906_00001.jpg

LM Start	1.10	Rating **	M	Issue No.	11
LM End	1.19	Issue Type +	Ma	Location *	LS
Category	Earthen Levee			GPS Latitude/Longitude	
				Start	End
Item	Animal Control			37.916354 °	37.916626 °
				-121.302471 °	-121.300918 °
DWR ID	DWR_RD0404_02_s_2012_11				
Comment Code					
A3 : No rodents visible, but rodent burrows visible; need to backfill and compact or grout burrows.					
Inspector Comment					
Grouting program is being used but is not effective.

Looking east at large rodent hole on landward slope.

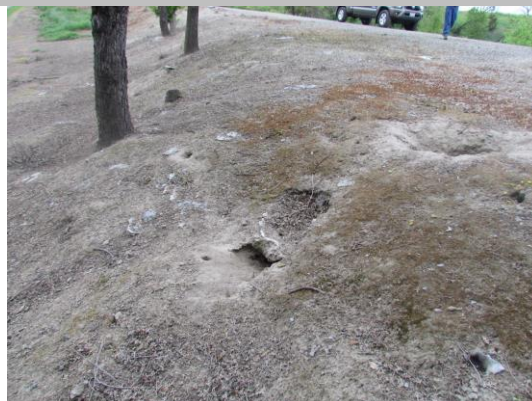
Photo 2 of 2 : FA_2018_RD0404_306_11_20180906_00002.jpg

Looking southwest at several rodent holes on landward slope.
